## **4. INTERMEDIATE FIELD TEST 2**

### **4.1 TEST 2 OBJECTIVES AND TEST PIT OVERVIEW**

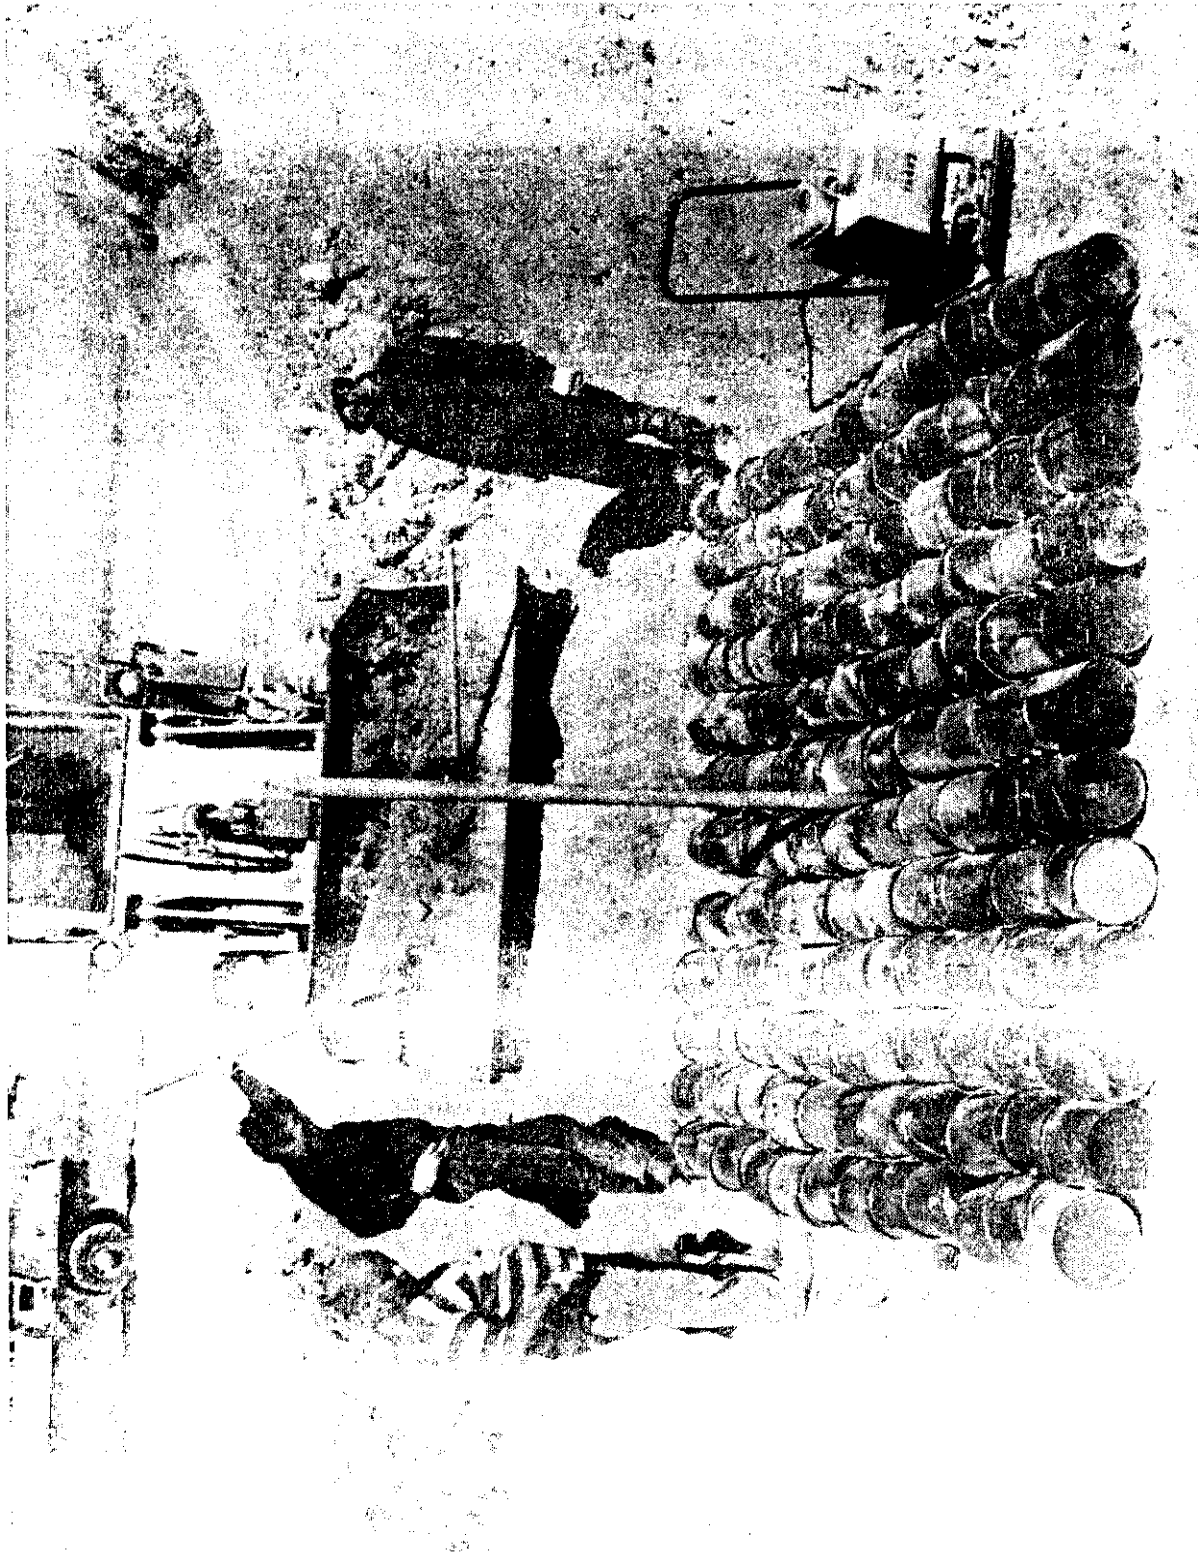
Figure 52. Bottom layer of cans in Test Pit 2.

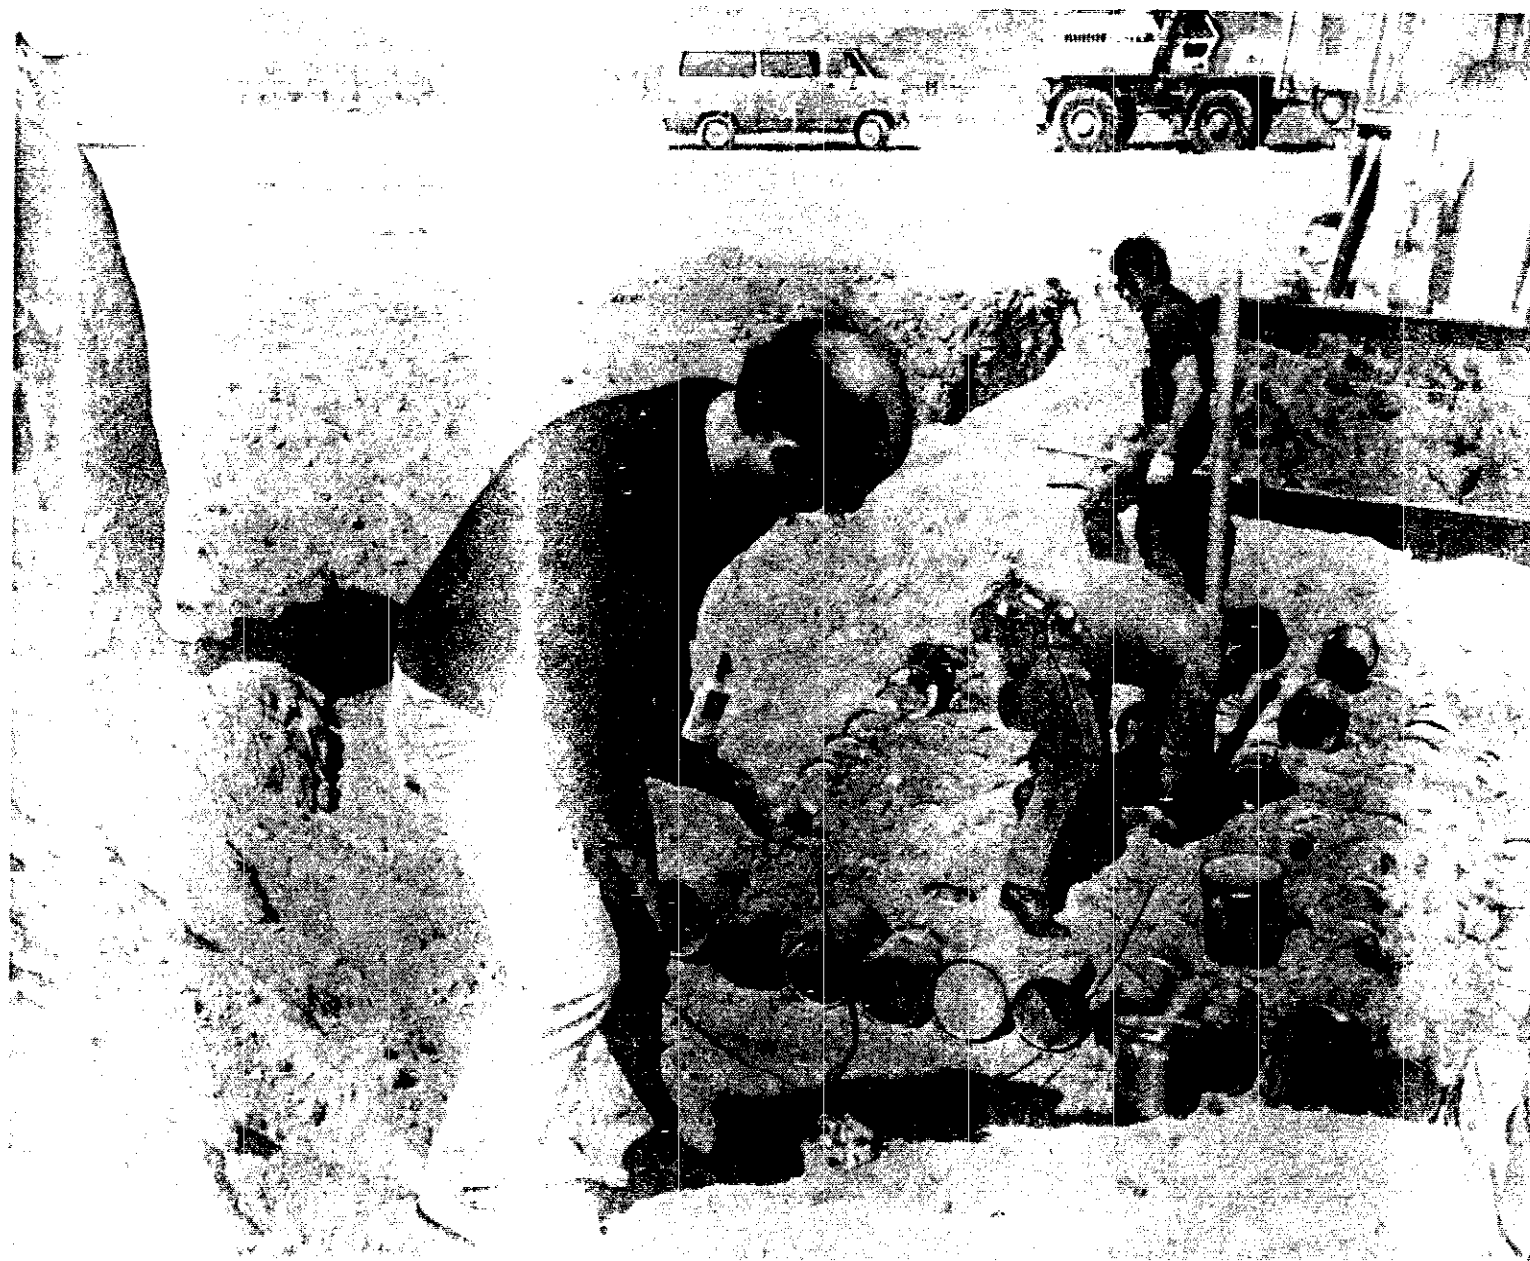
Figure 53. Placement of fill dirt between can layers in Test Pit 2.

During placement of the can layers, fill dirt was added to fill in the interstitial space between each layer, as shown in Figure 53. This figure also shows the placement of the horizontal array of thermocouples between the bottom and middle layers of cans. The middle layer of cans is shown in Figure 54. The dirt placed between the middle and top layers of cans is shown in Figure 55. Figure 56 shows the top layer of cans, and the final backfill is shown on Figure 57.
